5.0 FINDINGS

5.1 Past Waste Activity Review

The Idaho Chemical Processing Plant (ICPP) has operated as a nuclear re-processing plant since 1953. During this time, radioactive materials have been handled, and hazardous materials consisting primarily of acids, caustics, mercury, and miscellaneous chemicals have been used. Because the potential hazards associated with handling radioactive materials were recognized early in the history of the ICPP, care has been taken to minimize releases of both radioactive and chemical pollutants to the environment and to quickly clean up any spills that do occur. Furthermore, environmental releases at the ICPP have had only minimal impact on the public because of factors which were considered when the site was chosen many years ago. These factors include:

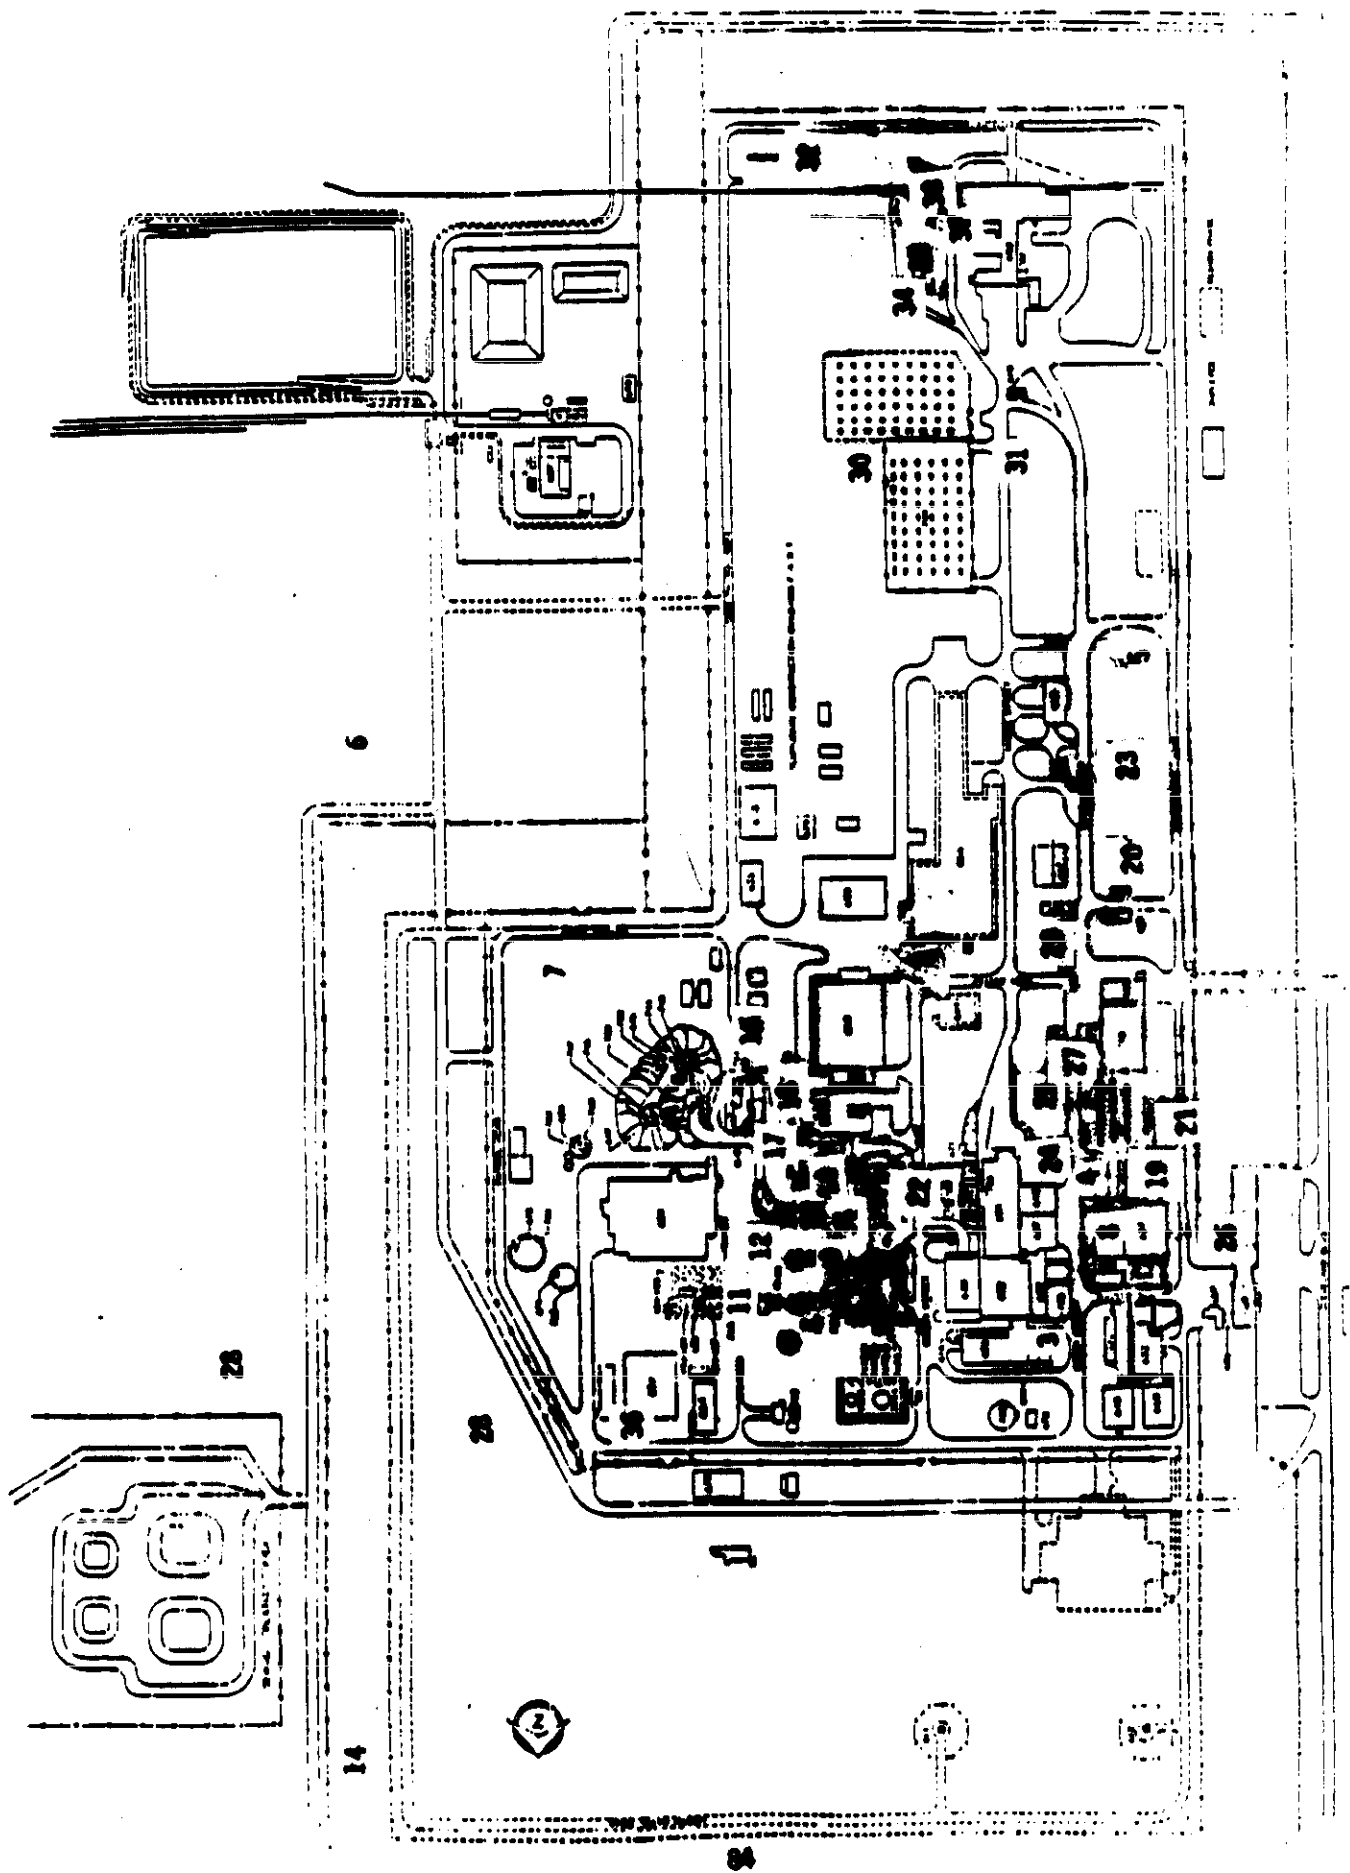
FIGURE 6.1 Location of Ranked Units at ICPP

Ranking results are shown in Table 6.1, and the location of these ranked units is shown in Figure 6.1. No units were found which are a cause for immediate environmental concern. However, two units require further study and possible action. Specific units are discussed in the following paragraphs.
